POPPLETON HISTORIC STUDY

B.2502

<u>Block</u>	<u>Lot</u>	<u>Address</u>
185	103-96	1015-1029 W. Lexington Street

B-2502
1015-1029 W. Lexington Street (1019 & 1021 demolished)
Block 0185, Lots 096-103
Baltimore City
Baltimore West Quad

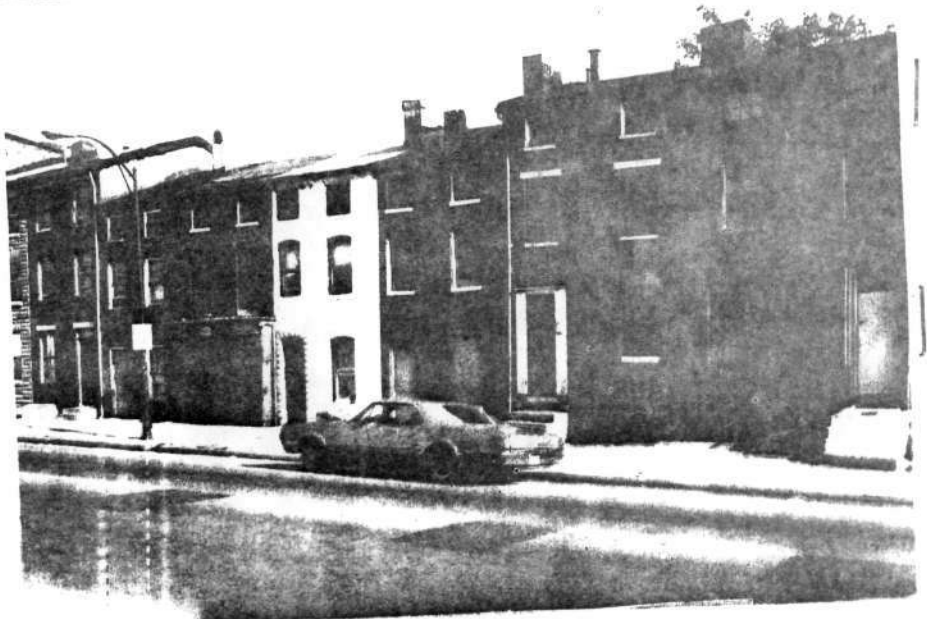
This group is about a decade older than the houses west of them. They are 2½ story, some are at street level or only a step above. They appear on the 1851 maps as part of a group which connected with a north-south lane running between Lexington and Fayette Streets at this point. Number 1029 has an original doorway applied at the time the windows were replaced with arched openings (1870's?). Number 1015 has been formstoned; 1023 has been stuccoed. Number 1021 had a storefront.

Vacancy rate is high: 1027, 1025, 1021. Others are in poor condition. (See comment for 1031-1047 W. Lexington Street.)

The entire group should be rehabilitated as small dwellings.
